Wire Rope Breakage on Centipede Activity

On 24/6/19 at 4:40pm, it was brought to the attention of Project Adventure Australia (PAA), that a wire rope (cable) which was the primary attachment for a Centipede activity, broke, resulting in the Centipede falling to the ground.

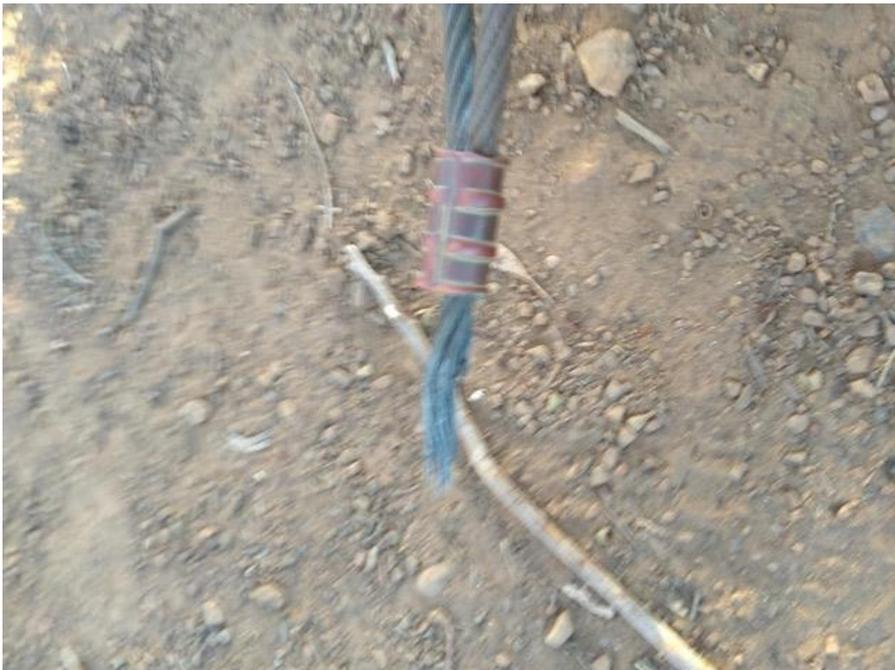
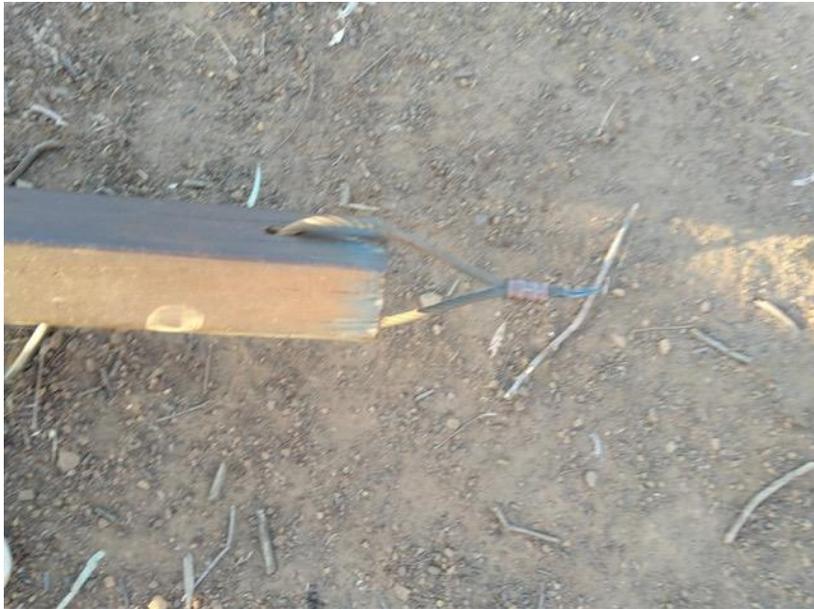
On 24/6/19 at 4.30pm, the activity was being climbed by a year 6 male when the Centipede attachment cable failed. The participant was being dynamically belayed at the time and was immediately lowered to the ground.

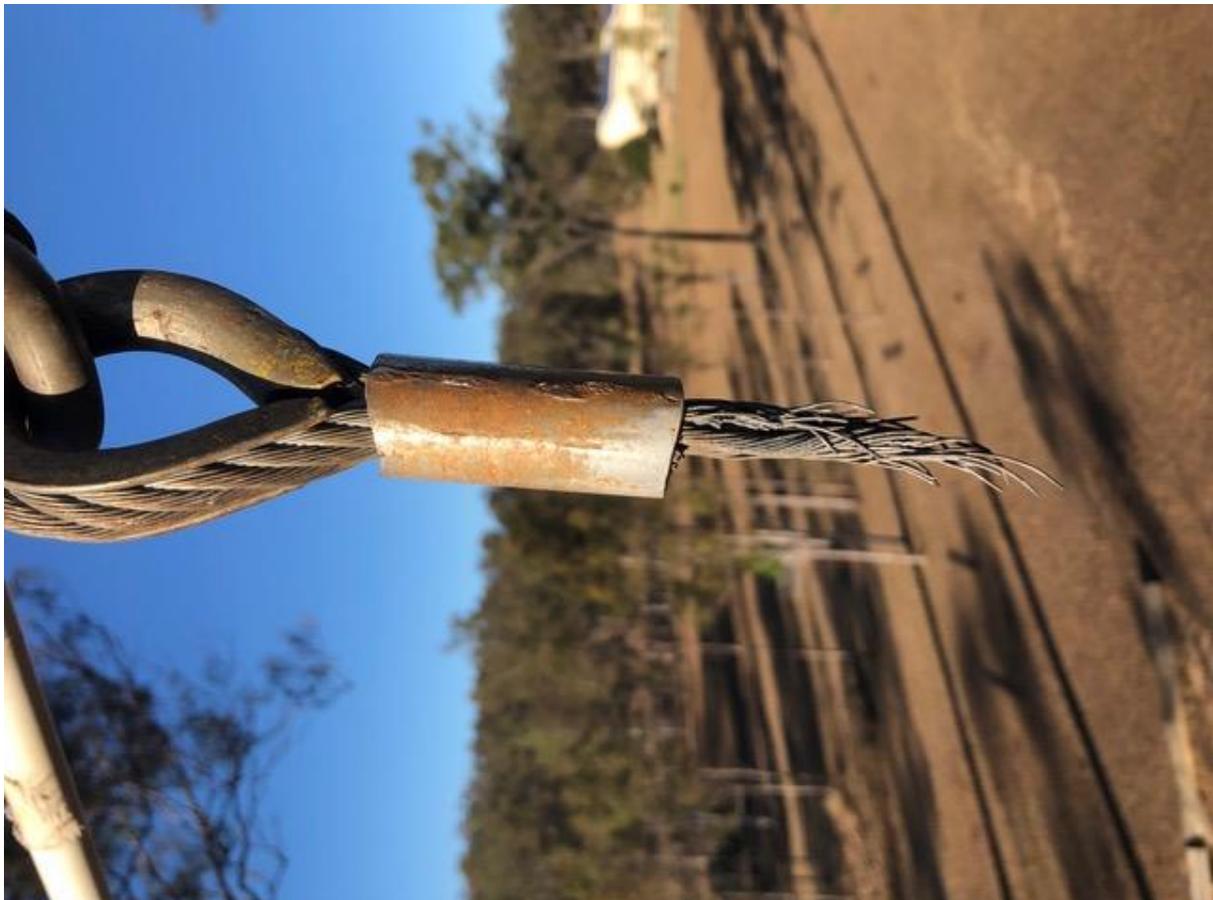
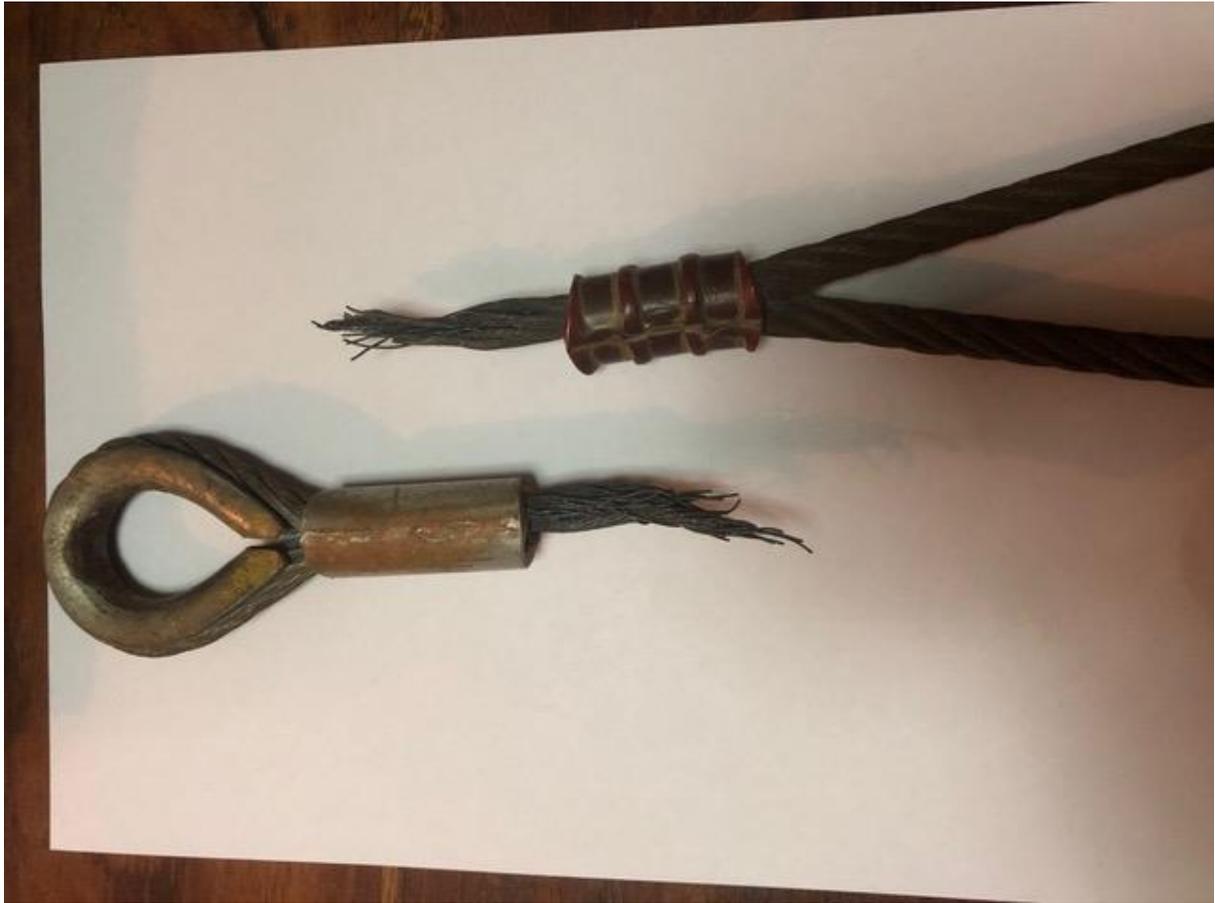
At some point, prior to the failure of the wire rope, the Centipede was twisted/wound many times from the ground in order to create a spinning motion of the Centipede when it was let go. This twisting/winding motion caused the strands of the attachment cable at the top of the centipede to twist open. This resulted in individual wires bending and subsequently breaking. Owing to the length of the Centipede, the leverage and torque achieved led to many of the individual wires and strands breaking.

The Centipede continued to be used as the damage caused by misuse was undetected by centre staff since the attachment point is difficult to see from ground level. The usual movement of the activity caused the remaining wires to break and the Centipede to fall.

Photos from broken centipede.

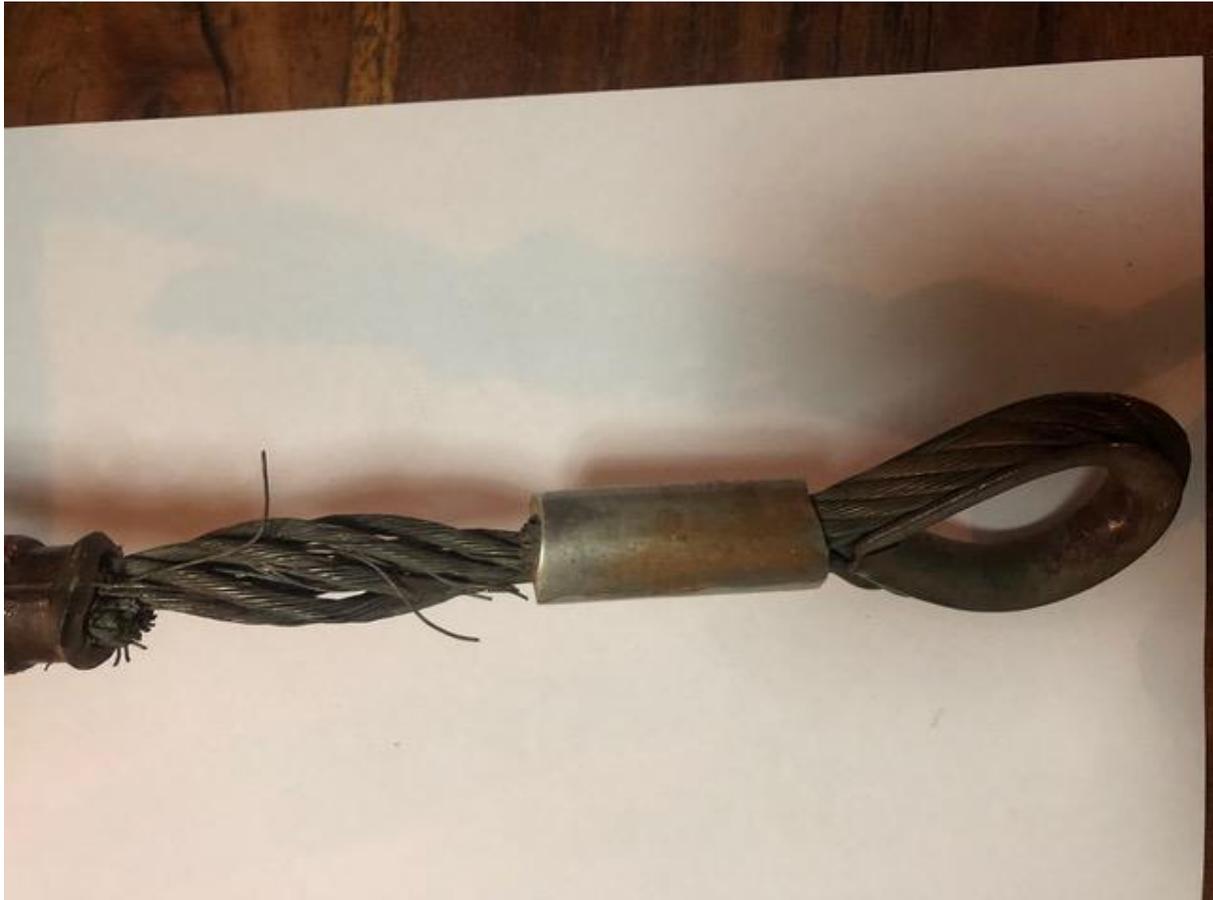
When I inspected the second centipede on the same day, it showed the initial signs of similar misuse with a few broken wires evident from similar winding/twisting. I went on to twist the Centipede another 3 times, noting that wires continued to break as I twisted.

This photo is the attachment point of the second centipede.
