Wire Rope Breakage on Centipede Activity

On 24/6/19 at 4:40pm, it was brought to the attention of Project Adventure Australia (PAA), that a wire rope (cable) which was the primary attachment for a Centipede activity, broke, resulting in the Centipede falling to the ground.

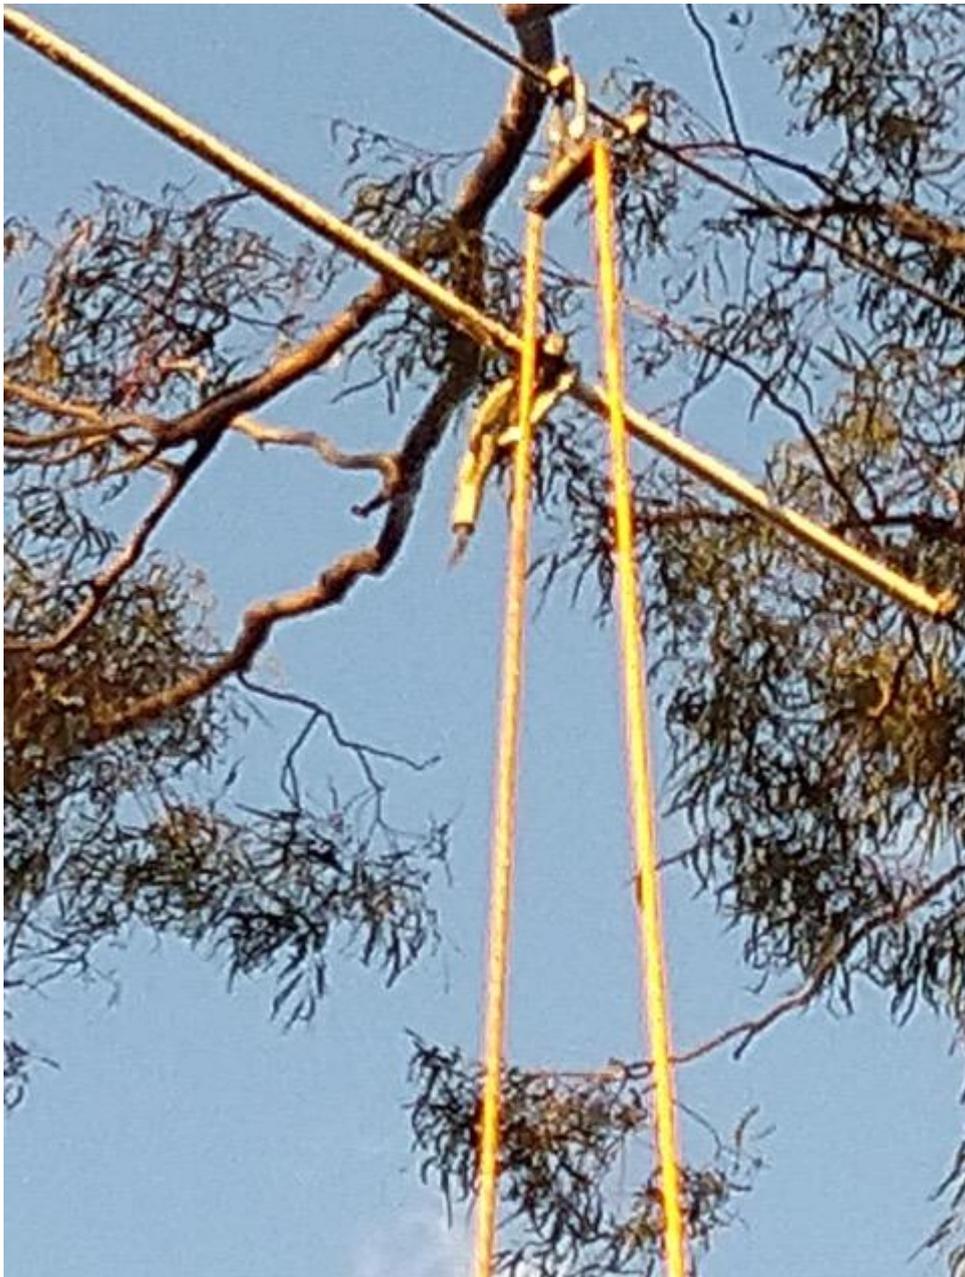
The determined reason for the failure of this wire rope was - misuse of the activity.

At some point, prior to the failure of the wire rope, the Centipede was twisted/wound many times from the ground in order to create a spinning motion of the Centipede when it was let go. This twisting/winding motion caused the strands of the attachment cable at the top of the centipede to twist open. This resulted in individual wires bending and subsequently breaking. Owing to the length of the Centipede, the leverage and torque achieved led to many of the individual wires and strands breaking.

The damage caused to the Centipede was more than likely unknown to the perpetrators, as the activity continued to hang as normal.

The Centipede continued to be used as the damage caused by misuse was undetected by centre staff since the attachment point is difficult to see from ground level. The usual movement of the activity caused the remaining wires to break and the Centipede to fall.
